Test Report

號碼(No.): ETR23803020 日期(Date): 21-Aug-2023 頁數(Page): 1 of 4

樣品名稱(Sample Name) : PORON NU-60

測試需求(Test Requested) : 依據客戶指定,測試鹵素-氟、氯、溴、碘。(As specified by client, to test

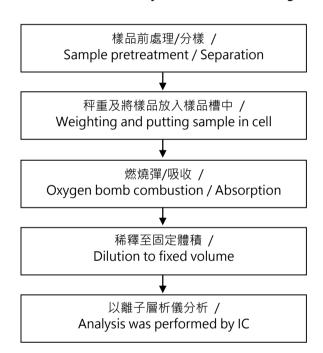
鹵素分析流程圖 / Analytical flow chart - Halogen

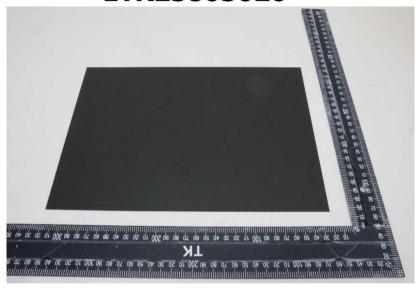
ETR23803020

* 照片中如有箭頭標示,則表示為實際檢測之樣品/部位. * (The tested sample / part is marked by an arrow if it's shown on the photo.)

No.1 : 黑色片狀 (BLACK SHEET)
